COMMERCIAL WINDSTORM MITIGATION REPORT (OIR-B1-1802)

Fareham Square Condominium Association, Inc.

301 2nd St N, Building B, Units 8-19

As of 7/22/2019

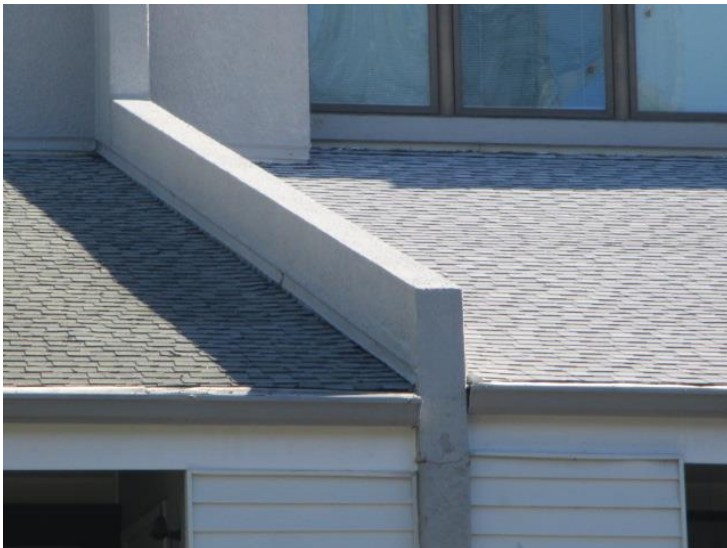
Roof Construction

2. **Roof Covering:** **FBC Equivalent**
Comments: The roof covering was replaced in 2006. The roof permit was confirmed and the permit number is 06-4000776 This roof was verified as meeting the building code requirements outlined on the mitigation affidavit.
